World War 1 and the Lickey Hills

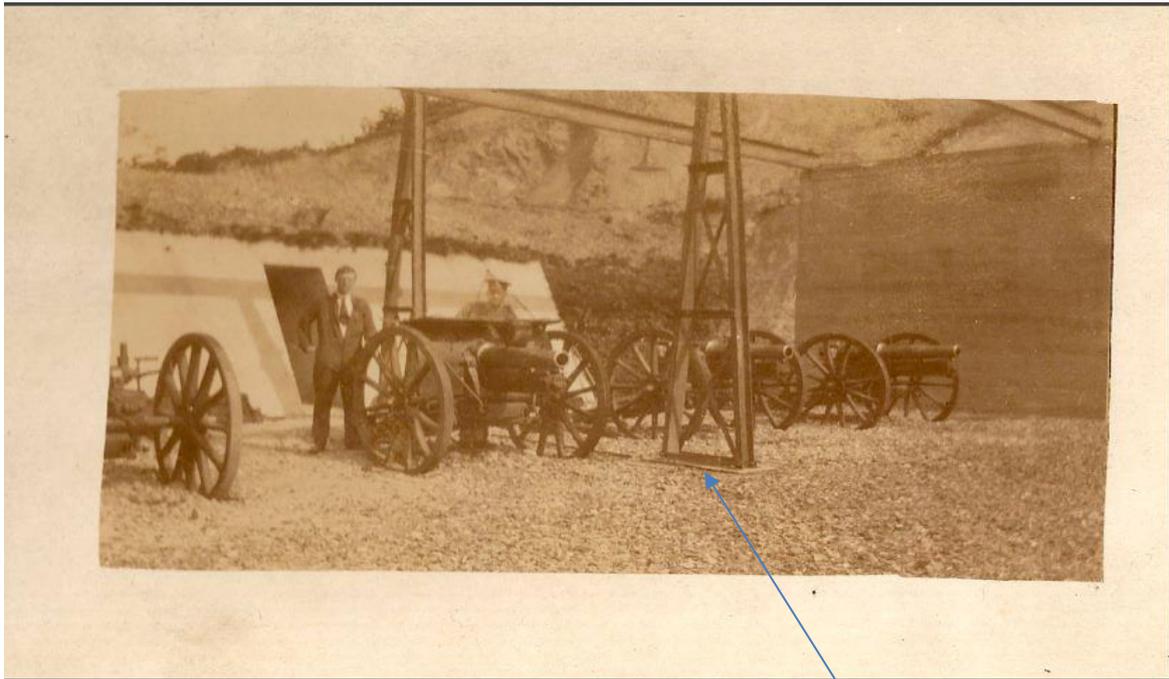
The Gantry

The metal gantry in this photograph has now gone. Can you find the foundation stone in the middle of the quarry?

Notice the wall (now demolished) acting as support for the gantry. This ran along the side of the quarry right up to the front edge of the proof butts. It was built to protect the quarry from damage and prevent loose stones from falling, endangering workers.

It is thought it was used to lift the heavy gun barrels onto the gun carriages ready to be tested.

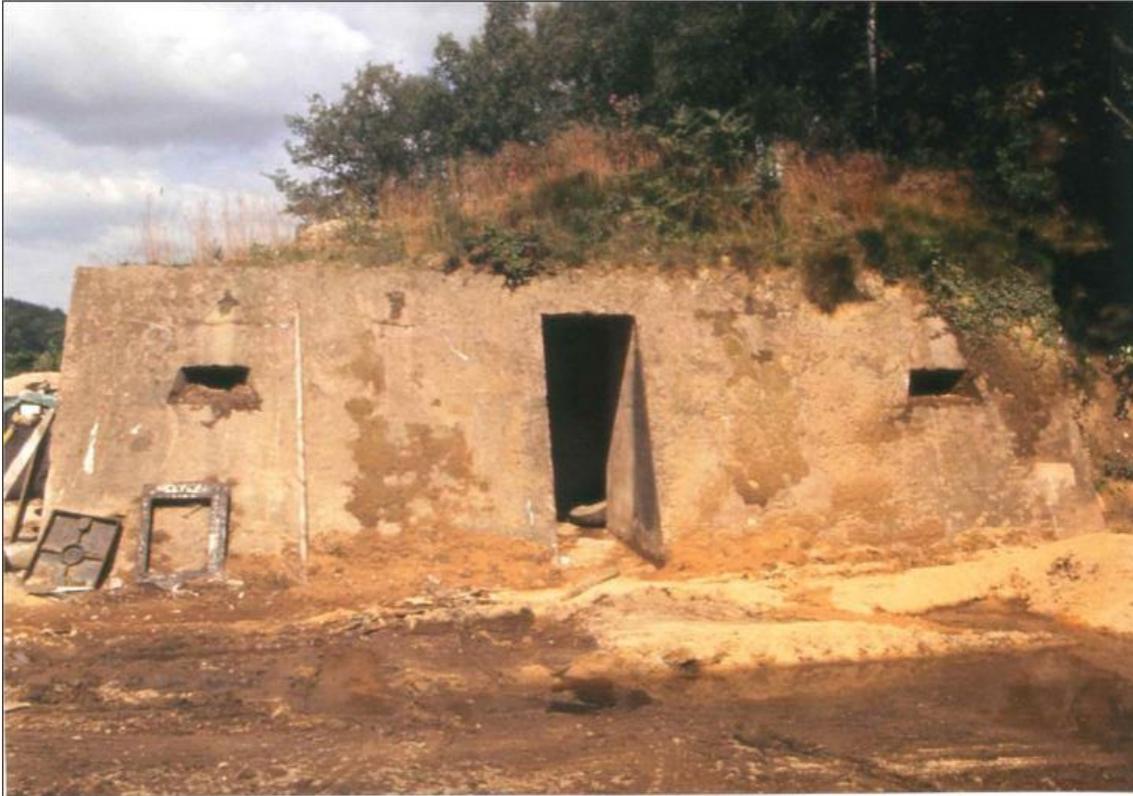
The Bunker

This is another photograph of the bunker. Was it taken before or after the photograph of the Bunker on the previous page? (it is behind the field guns and gantry). Can you say why?

It looks old, vegetation has grown up on its walls/roof and two slits have been cut into the walls. This was taken shortly before it was demolished in the 1980s. Notice the slits cut on either side of the entrance. These were adaptations made in later years when the site was used as a firing range for small arms, possibly for Home Guard training in the Second World War.

As its name suggests it was for those firing the guns to take refuge in while the gun was fired. When they were proofing guns (proving that they were fit for purpose) there would have been incidents of guns failing and therefore being very dangerous to those testing them. The guns would have been fired by remote detonation. This could be by the use of a lanyard to trigger firing from the safety of the bunker.

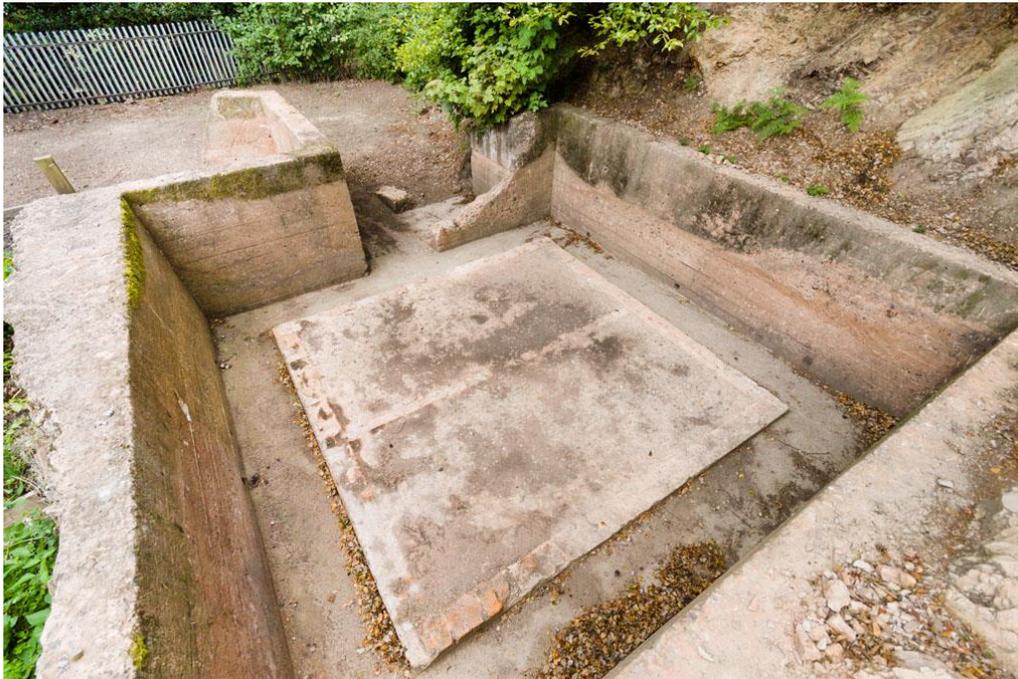
Magazine (Munitions Store)

Find the base of the building located in the top left-hand corner of the quarry.

A store for explosives would have been required. This building is located in, what was at that time, a completely separate part of the quarry. It would have had quarry walls to three sides; the side to the left in the above photograph is now demolished. It follows the construction conventions of a munition store; a dog leg entrance corridor and angled walls to encourage an upward failsafe explosion. The outside shell was constructed in concrete with the inner chamber built in brick. There appears to be a separate small store at the entrance (top, middle of photograph) which would have been suitable for storing detonators.

It would most likely have had a wooden floor to stop the possibility of a spark (caused by metal on boots striking the stone floor) igniting the stock it held.
